Important Information Please Read Completely

These instructions are for the enclosed replacement Plug for the secondary gearbox installed on 1985 through 1988 Suzuki GV1400 Cavalcade motorcycles. It replaces Suzuki part #09241-25004 and fits into the case-end of the driven gear inside the secondary gearbox.

Installation Instructions for the Replacement Plug

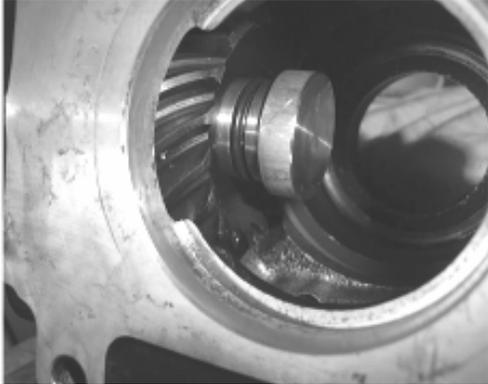
2) With the secondary gearbox on the bench, look inside through the motor-side seal and see if the stock plug is still in place in the front of the driven gear. If it is, drive it out by inserting a punch through the back-end of the driven gear and knock it into the gearbox and then discard it. If the plug was already out, remove it and discard.

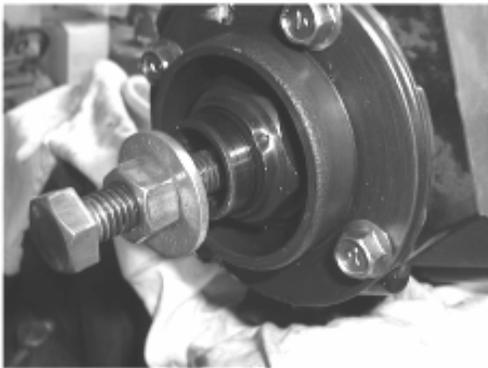
3) Unscrew the 1/2" full-threaded bolt from the back of the replacement Plug. Put a small amount of lubricant on the o-ring and insert the threaded end of the Plug into the hole in the front of the driven gear as shown in the photo. This is made easier if the motor-side seal is removed. It is always good practice to replace the seal whenever the gearbox is removed from the motor. The seal is Suzuki part #09283-48012.

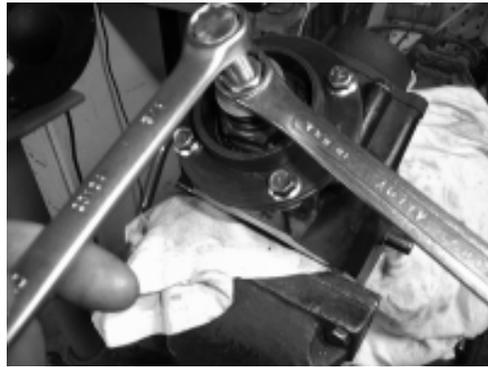
4) With the nut and washers on the bolt as it was delivered, insert the end of the full-threaded bolt into the back-end of the driven gear and thread it into the replacement Plug. You may need to grasp the Plug and hold it while threading the bolt into it. The bolt need not be tight but should thread in until resistance felt. It should thread into the Plug about 3/4". If you fail to thread it in far enough, the threads may pull out of the Plug as it is being drawn into the gear.

5) Put a few drops of oil on the threads of the bolt just above the gear and some on the face of the washer that will contact the nut. Thread the nut towards the back-end of the driven gear until the washer contacts the face of the gear.

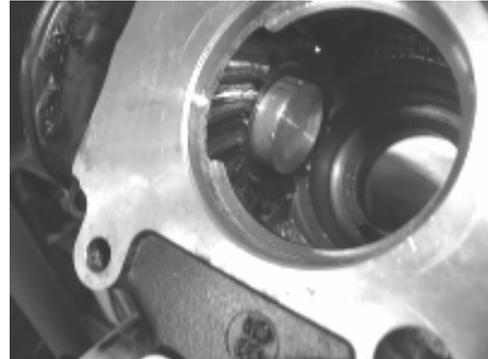
6) Using 2 - 3/4" end wrenches or a 3/4" socket and 1 - 3/4" end wrench, hold the bolt while threading the nut towards the driven gear (clockwise when looking at the head of the bolt) as shown in the photo. If the gear tries to turn when you turn the nut, the bolt will thread out of the Plug and it will not be drawn into the gear. If this happens, loosen the nut and insure that the bolt is threaded into the Plug fully and, using a thin piece (approx 1/8" thick) of soft metal such as aluminum, brass or copper, lock the gears from turning by wedging the end of the metal between the gears as they try to turn (you may need an extra hand for that). Thread the nut back towards the driven gear and using the wrenches, continue to draw the Plug into the gear.

7) While drawing the Plug into the gear, there will quite a bit of resistance felt at the wrenches. If there is not, please stop and contact me. The plug is designed as a considerable "press-fit" and if it pulls in too easily, then it will not stay in as designed. When the Plug is fully drawn into the gear, the head of the Plug will contact the face of the gear as shown in the photo. This will be felt at the wrenches as they will become nearly impossible to turn further. Loosen the nut and remove the bolt from the Plug.
